FOREST PRODUCTS RESEARCH IN PICTURES

NO. 66

**VALUE OF DECAY PREVENTATIVES  
DEMONSTRATED**

**FOREST PRODUCTS LABORATORY  
U. S. FOREST SERVICE  
MADISON, WISCONSIN**

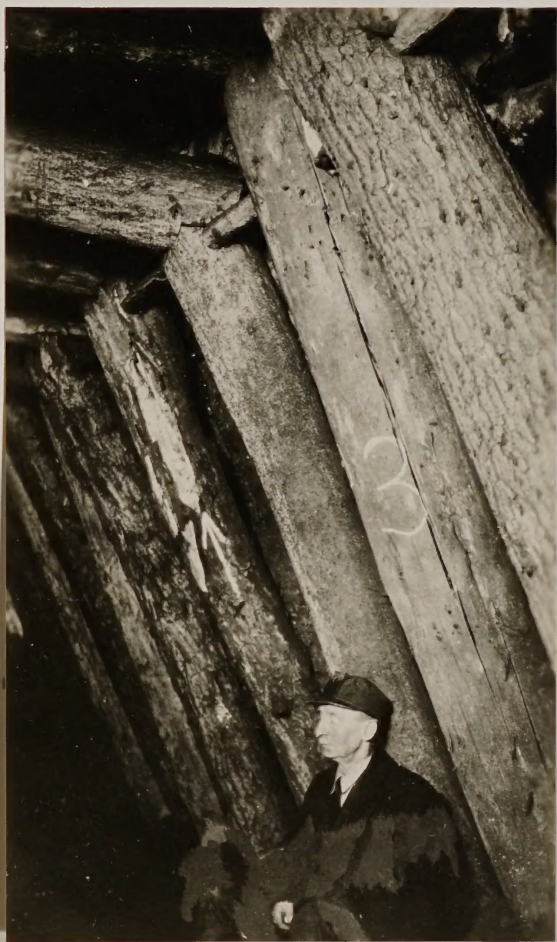
The mine timber marked "3" was installed after treatment with zinc chloride in 1908 and it is still sound after 17 years of service. The untreated timber marked with the arrow is decayed and due for early replacement. This timber was installed only four years ago to replace a treated timber which had been in service for 14 years. The original treated cap of this set, seen supported by the decayed timber, is sound in its eighteenth year of service.
